Fall and Rise: Changes in the Fish Community of Triplett Creek Following Restoration of a Channelized Reach

Austin Spradlin*, Jon D. Eisenhour, and David J. Eisenhour
Department of Biology and Chemistry, Morehead State University

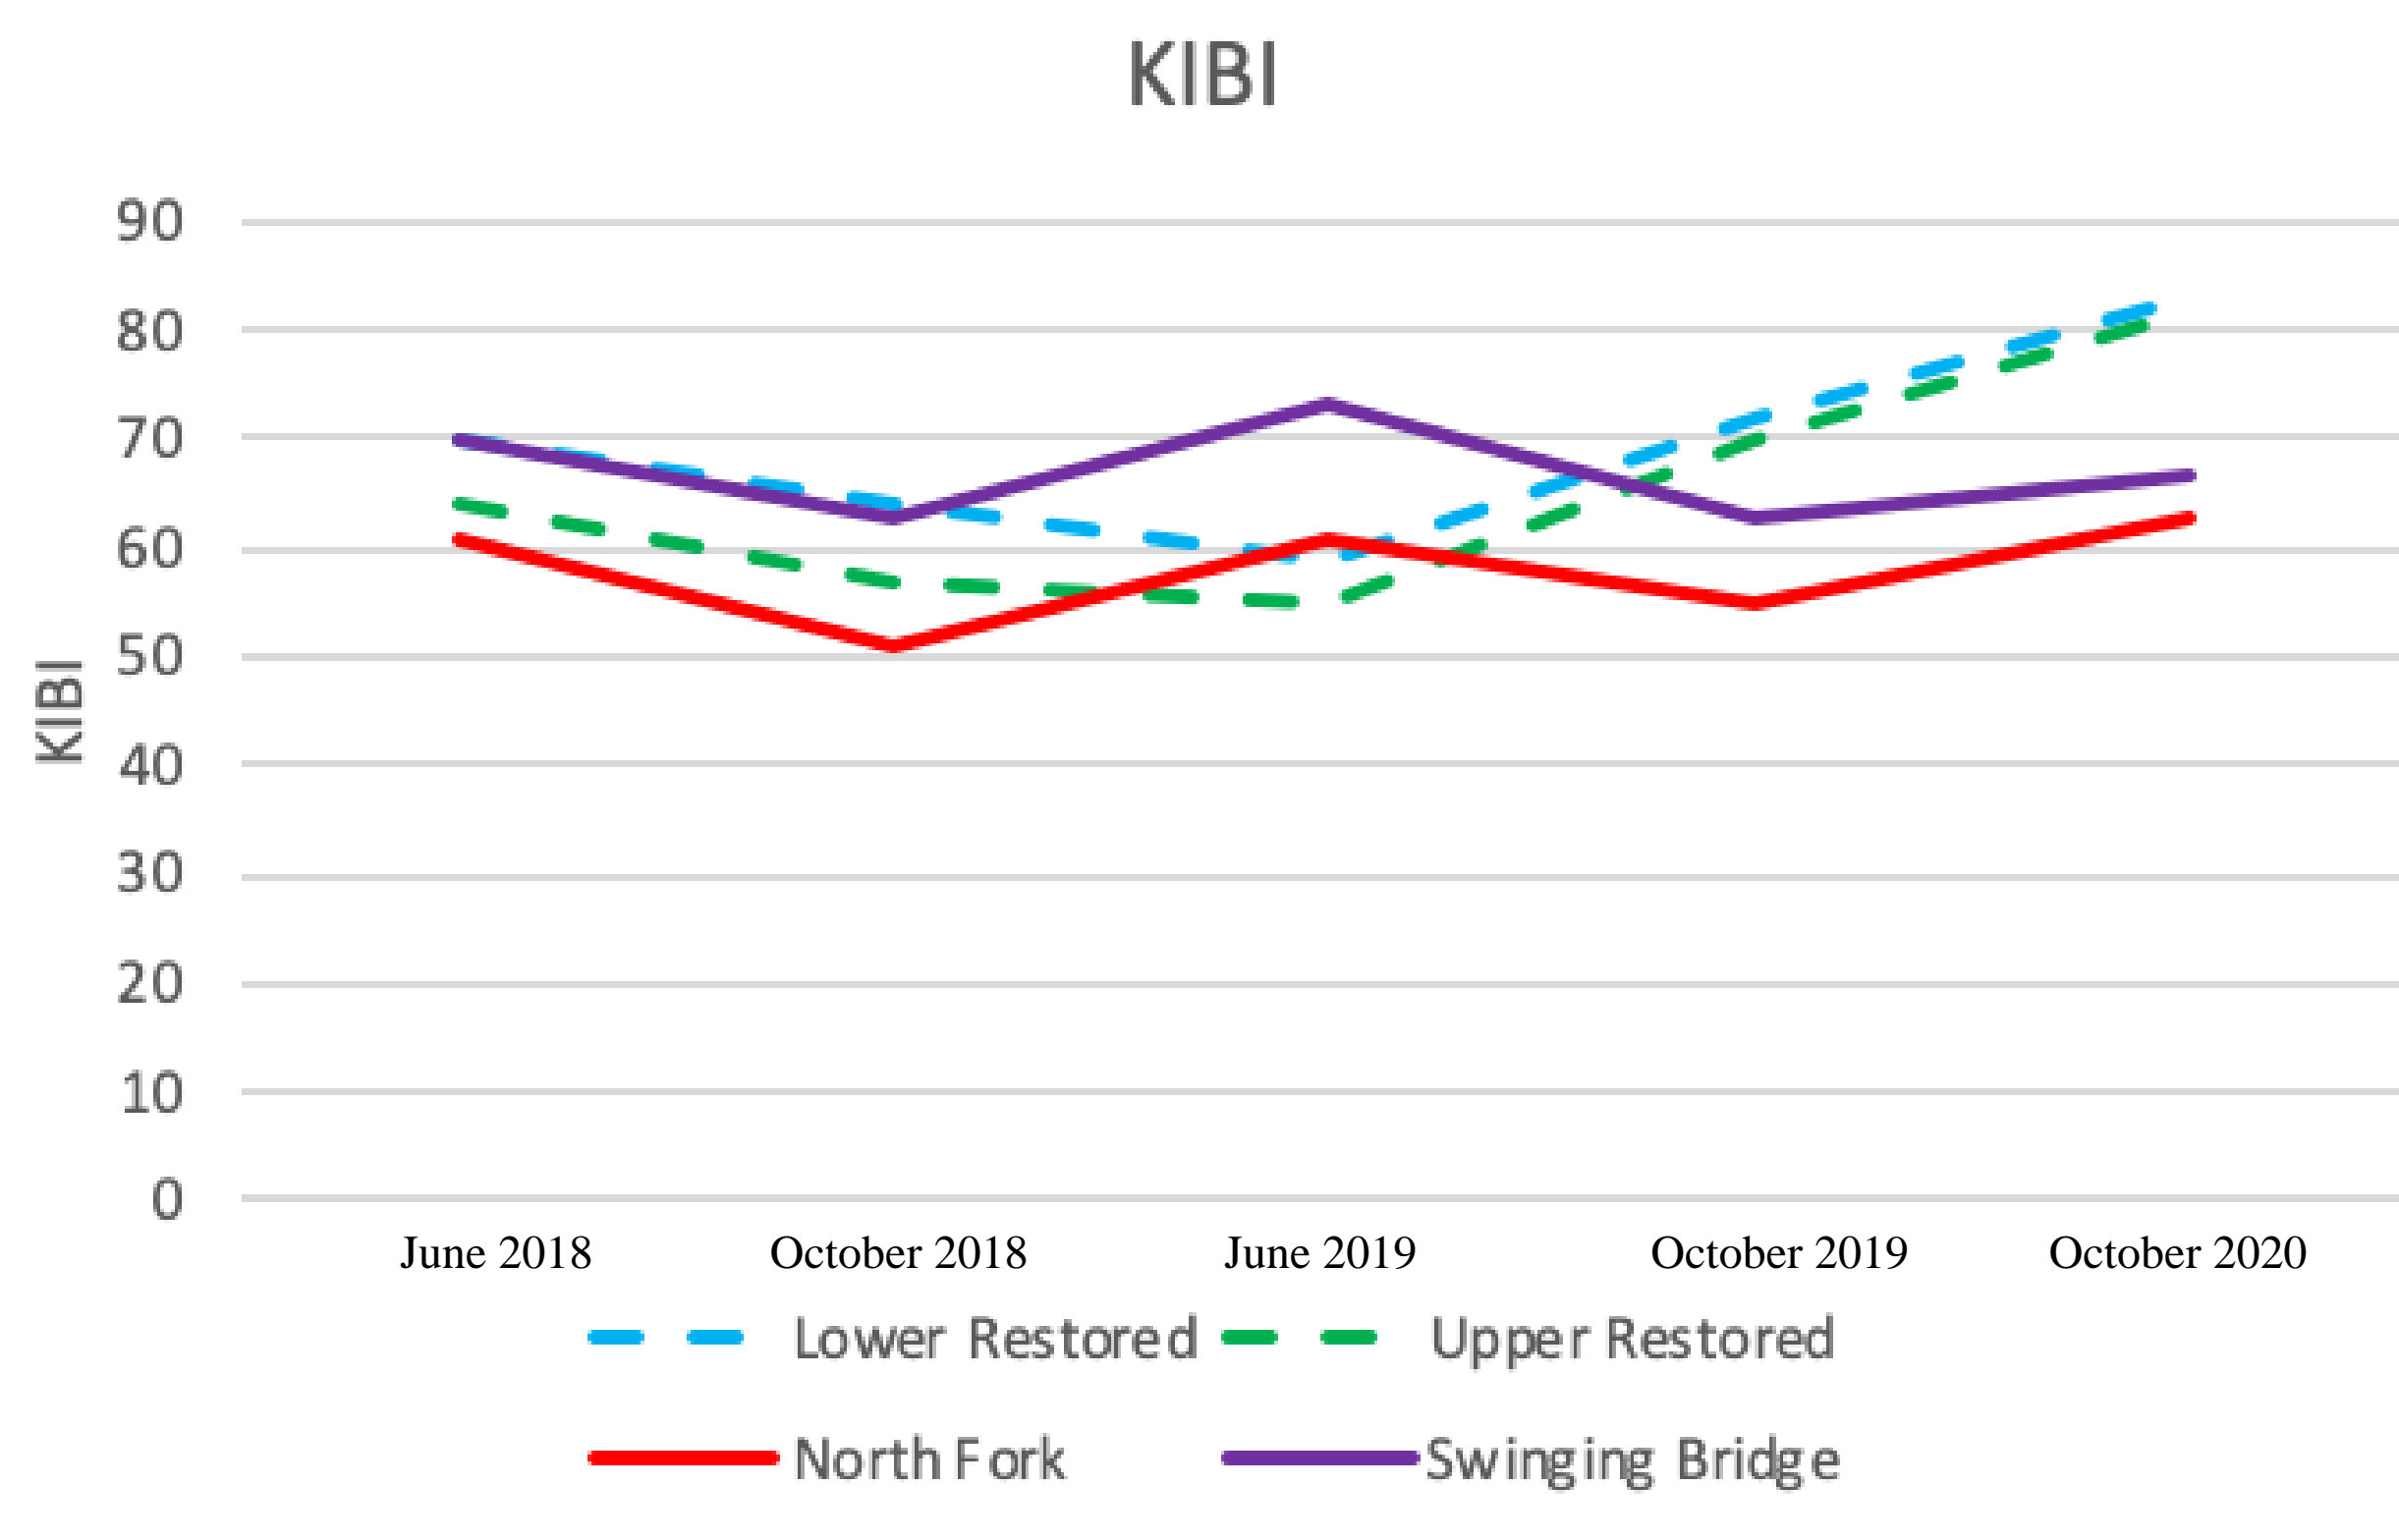
Figure 5. Kentucky Index of Biotic Integrity (KIBI) scores for four sites sampled five times.

Changes in Fish Community.—In June 2018, prior to restoration work, the four sites had KIBI scores between 59 and 70, all of which rated as “good” (Figure 5). However, the two sites in the restored area had a higher proportion of nonnative species (Figure 6), and fewer darters compared to the control sites. In October 2018 and June 2019, after restoration work, the restored sites declined slightly in KIBI scores (Figure 5), had reduced number of species detected (Figure 9), especially species considered “intolerant” by the KIBI (Figure 8), and had reduced number of darter species, while remaining about the same in the control sites. **However, in October 2019 and October 2020, much of these metrics had greatly improved in the restored sites** (Figures 5 and 9). In fact, the October 2020 KIBI scores for both restored sites were considered “excellent.” Of particular interest was the change in a highly intolerant species, the Bigeye Chub, in the restored area: formerly of low abundance, it disappeared after restoration, but then reappeared in high numbers recently (Figure 7).

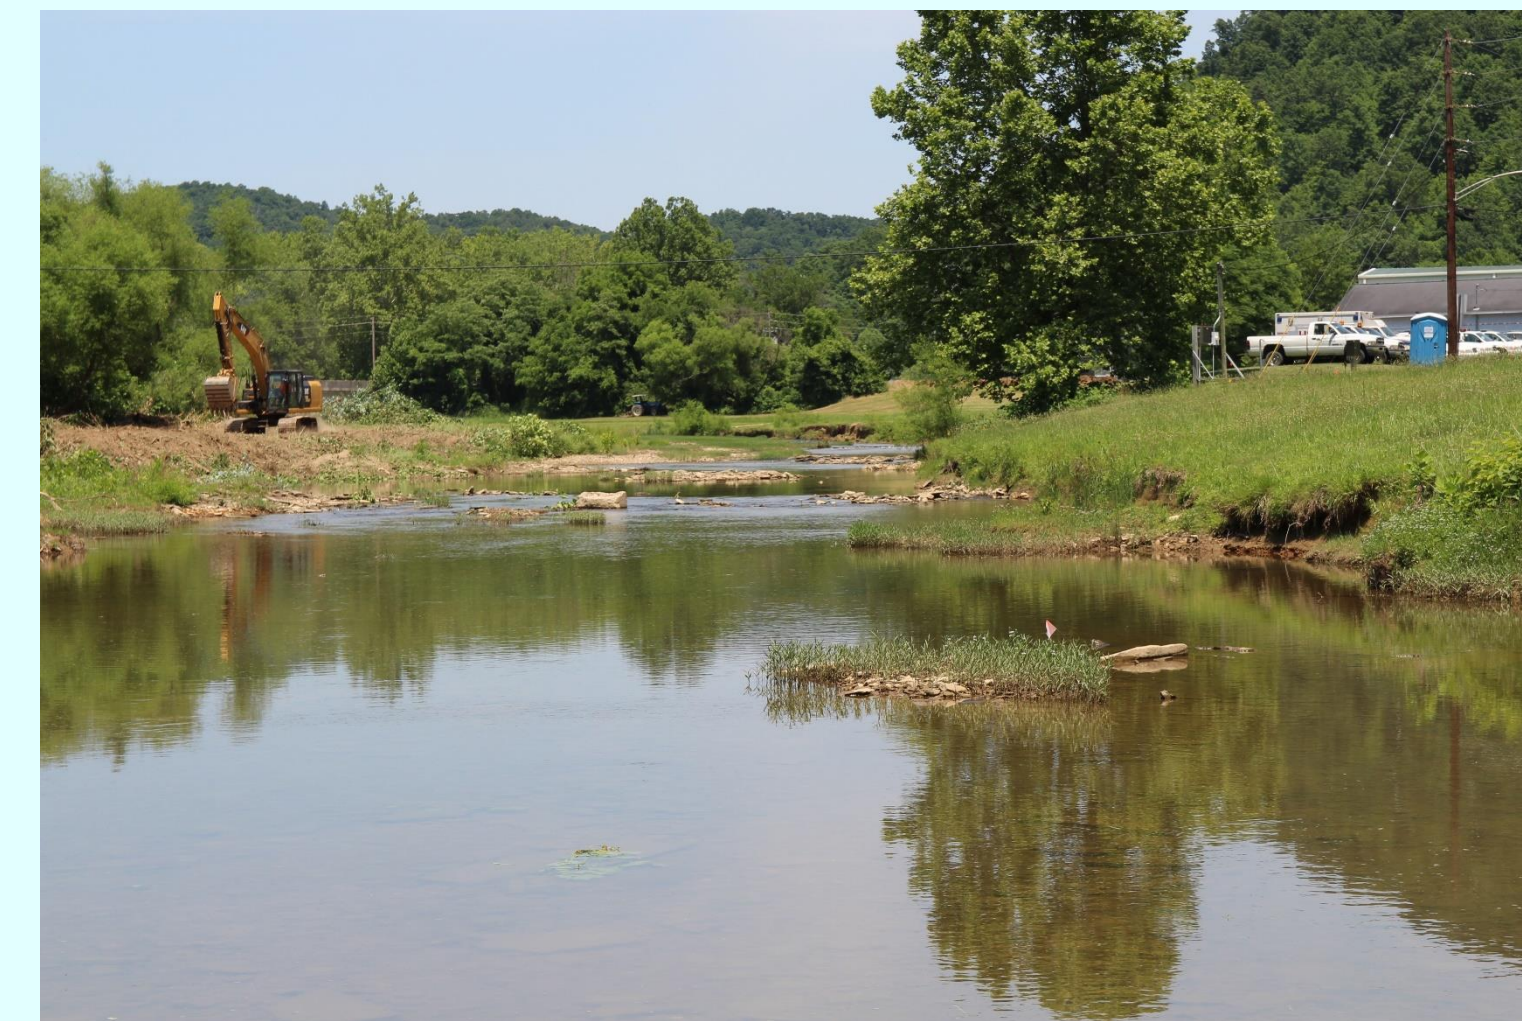
Figure 2. Upper Restored site, just before restoration, with earth-moving equipment visible in the background.

Changes in Habitat.—The habitats of the control vs the restored sites were quite different (Figure 10); the restored sites were wide and shallow, dominated by bedrock, and had little aquatic vegetation and submerged woody debris (Figure 2). After restoration, PCA scores of control sites changed little, while those of the restored sites changed considerably, initially becoming more like the control sites in habitat (Figure 4). Since October 2018, however, the habitats of the restored sites have slowly returned to their original state.

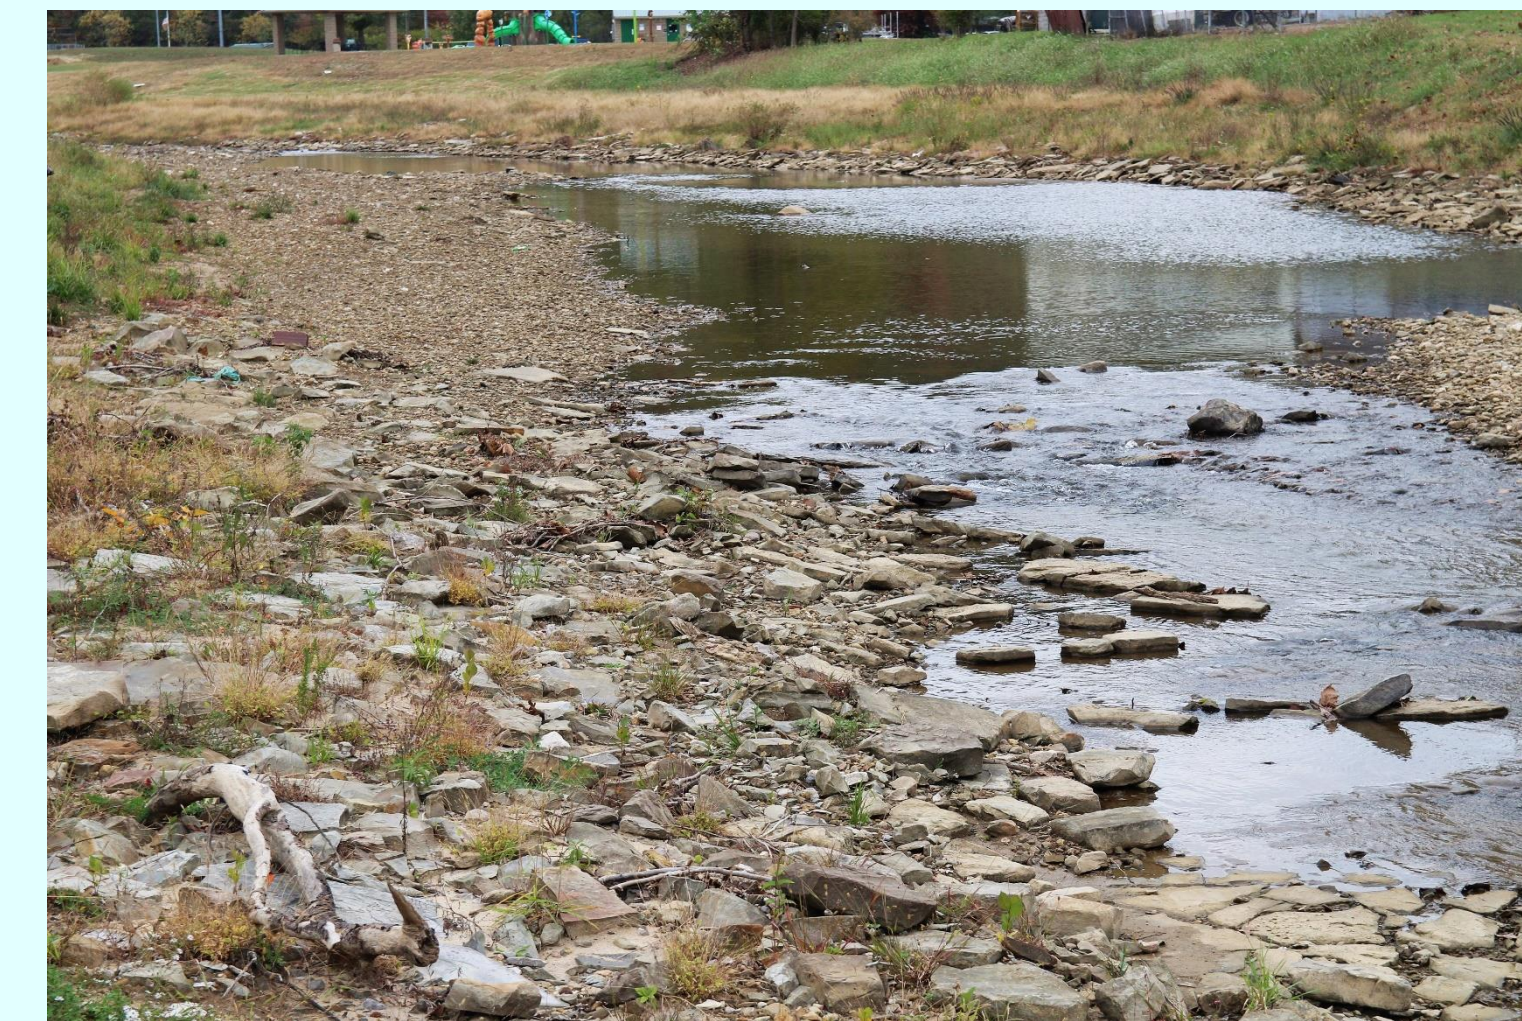
Figure 4. Upper Restored site after restorations (October 2019).

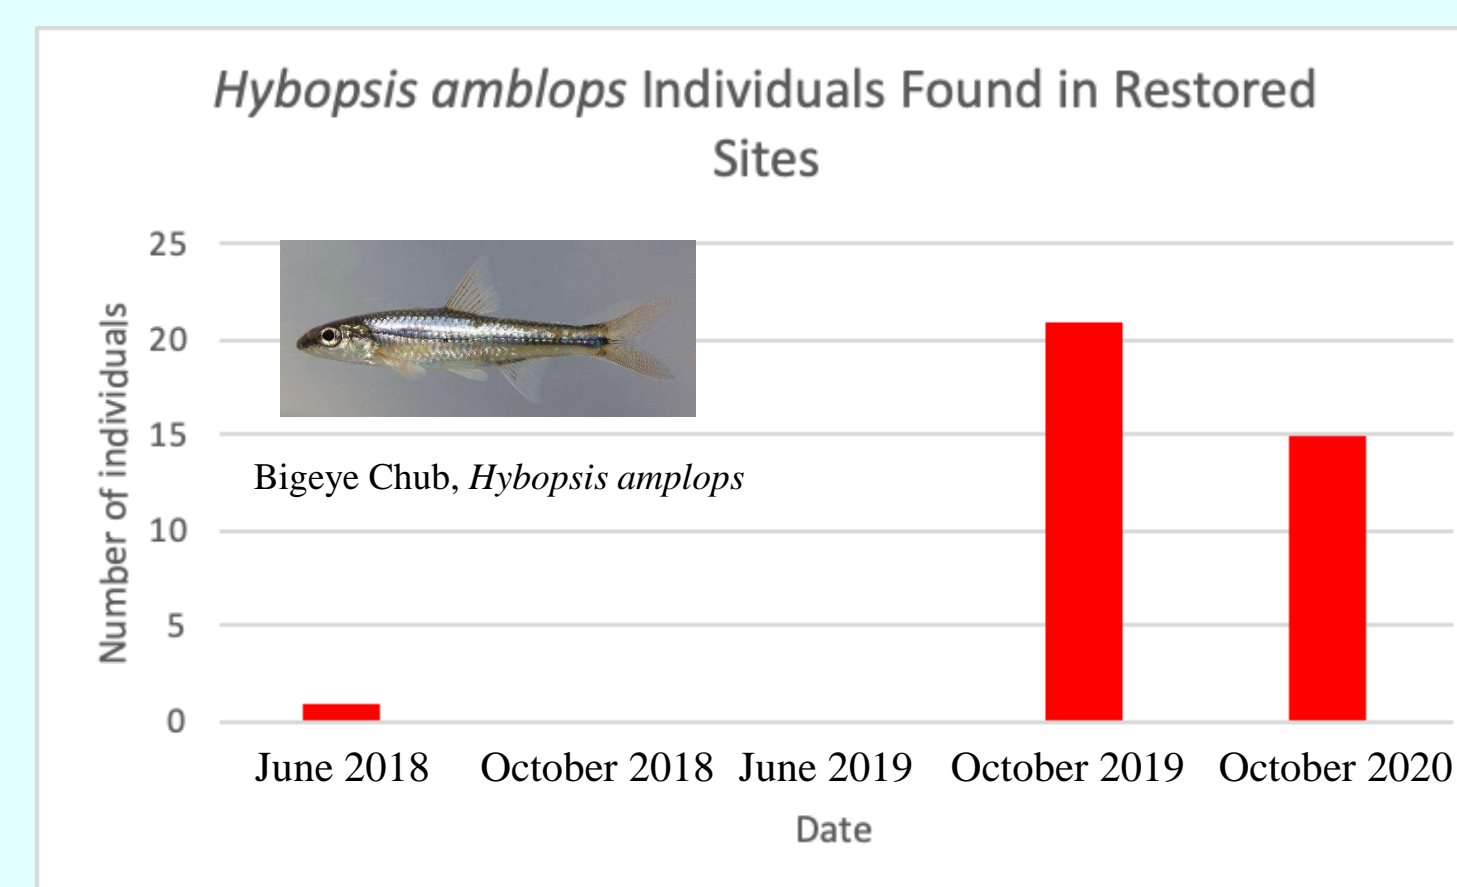
Figure 7. Number of individuals of *H. amblops*, an intolerant minnow species, found in the restored sites.

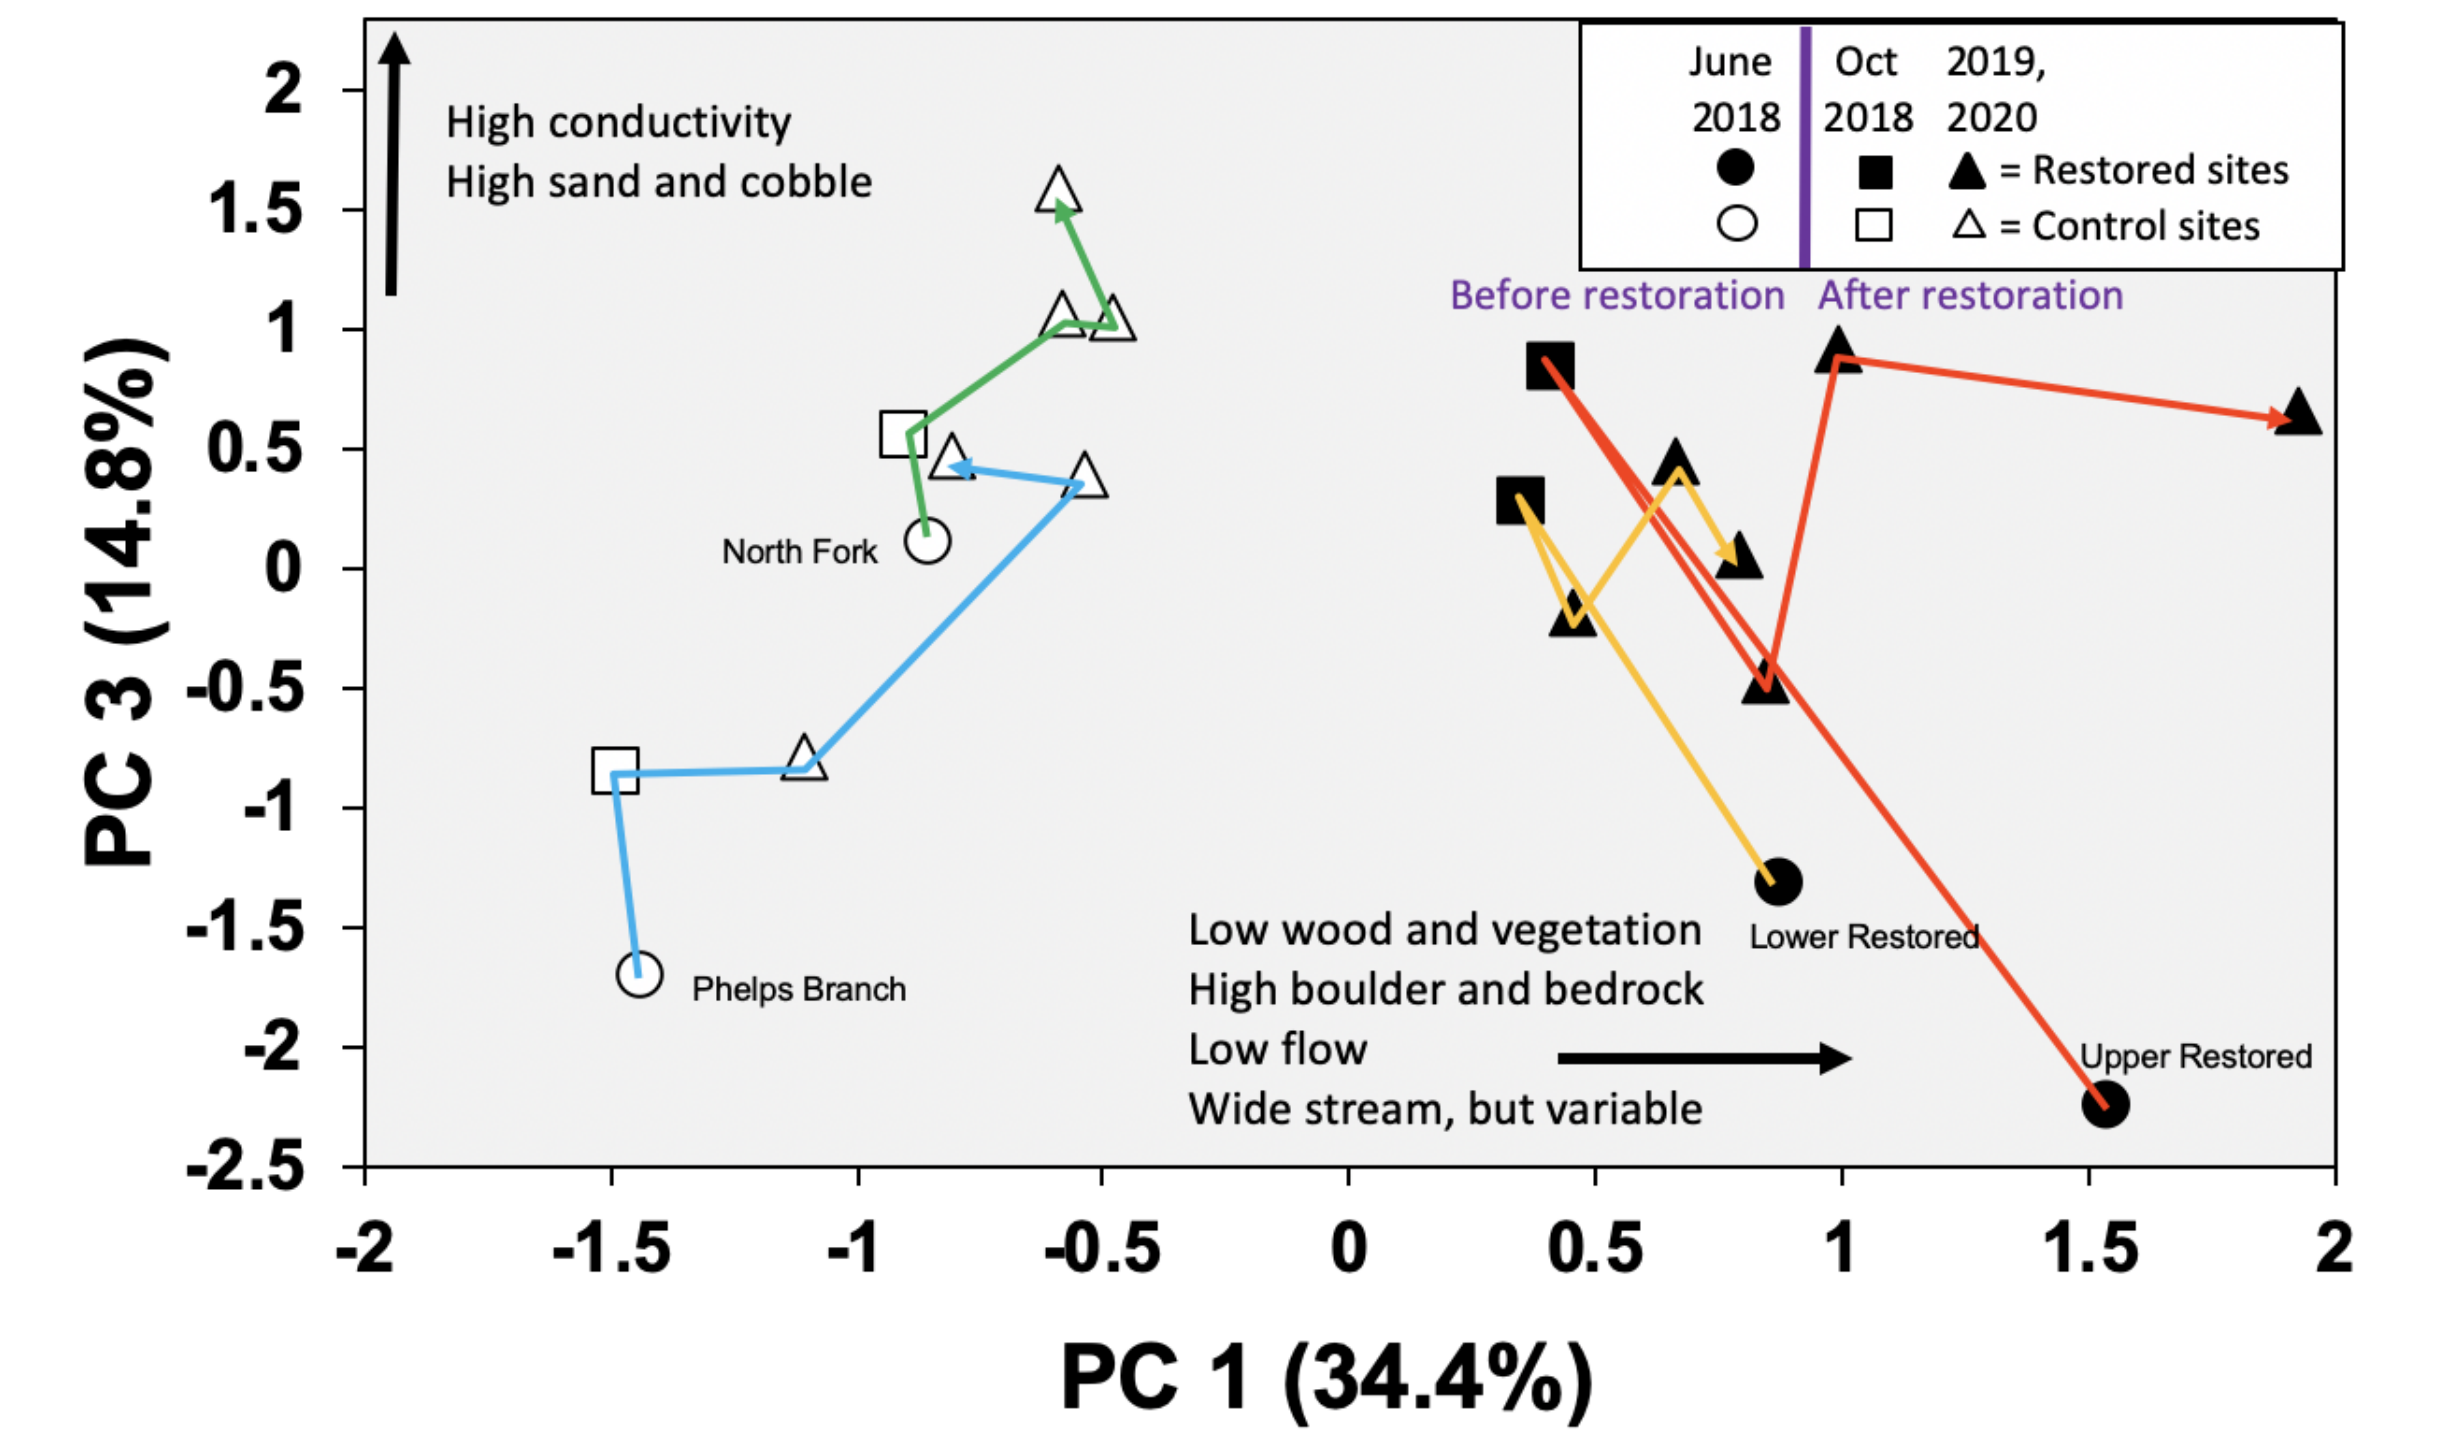
Figure 10. Habitat scores of 16 samples on PC axes 1 and 3. Arrows indicate habitat changes throughout the duration of the project.
