Geologic Structure and Mine Roof Falls in Selected Coal Beds Within Appalachia

David Hylbert

Research Report No. 8
APPALACHIAN DEVELOPMENT CENTER
Morehead State University
Morehead, Kentucky

Geologic Structure and Mine Roof Falls in Selected Coal Beds Within Appalachia by David Hylbert, March 1984. (Research Report Number 8.)

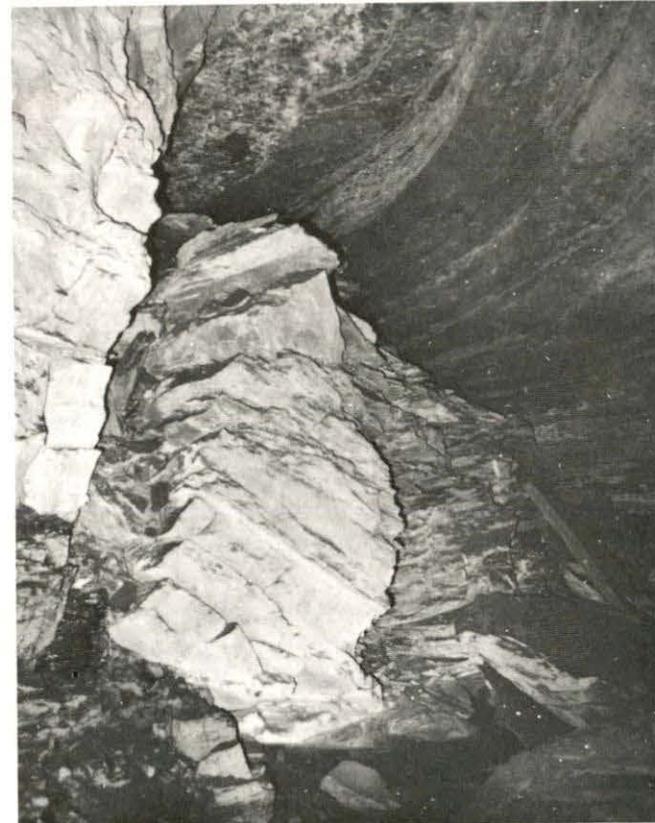
Figure 12. Entrance and Underground Views of Siltstone/Shale Roof at Southeast Coal Company's Polly Number 4 Mine

A. Entrance to portal of Southeast Coal Company's Polly No. 4 mine. Shows laminated siltstone and shale with rider coal bed beneath sandstone ledges about 15 feet above portal..

B. View inside mine with fall extending upward to position of rider coal bed.

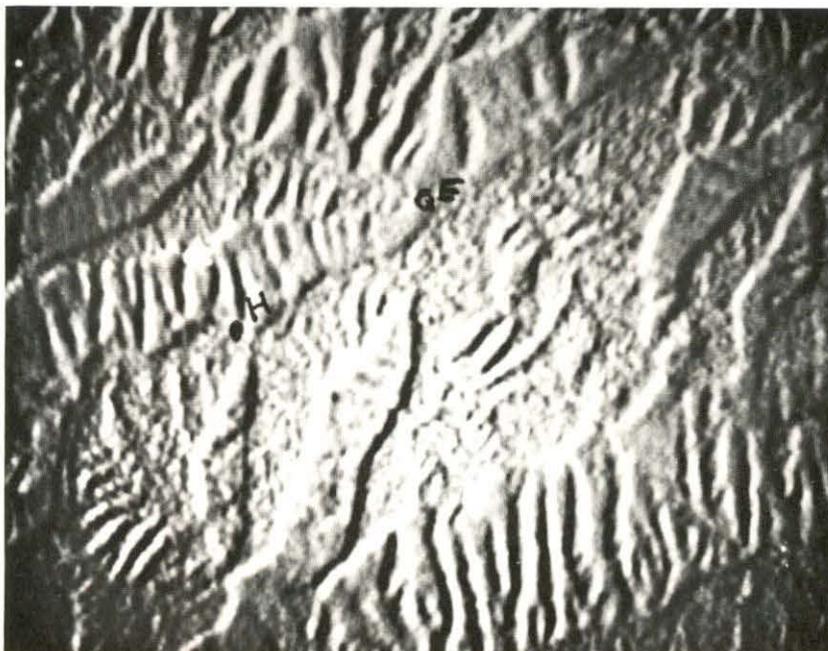
Figure 27. Photograph of Monitor Screen Showing Contrast Edge Enhancement of Imagery Film*

*Geographic reference points shown by "E" and "H."

Method B-Video Enhancement Method. The second method involved the implementation of a video-enhancing system. The video-enhancing system is essentially a film densitometer which electronically detects and correlates tonal (gray level or photographic film density) present in satellite imagery film transparencies. Variations in the film density seen by the television camera (or scanner) are "edge enhanced" or "color enhanced" and displayed on monitor screens. Thirty-five mm color slides of the television monitor screen were taken and then projected onto the topographic base maps as in the Ronchi grating method. Comparatively speaking, the video-enhancing system is more effective in detecting tonal linear features than the Ronchi grating and also delineates ridge and valley alignments with results reasonably comparable to the Ronchi grating method (Figures 27 and 28).
